PROGRAM TITAN IIIM

STANDARD SPACE LAUNCH VEHICLE
COMPONENT DEVELOPMENT REPORT

FOR THE
TITAN IIIM STAGE I COMBUSTION CHAMBER

9180-941-DR-3

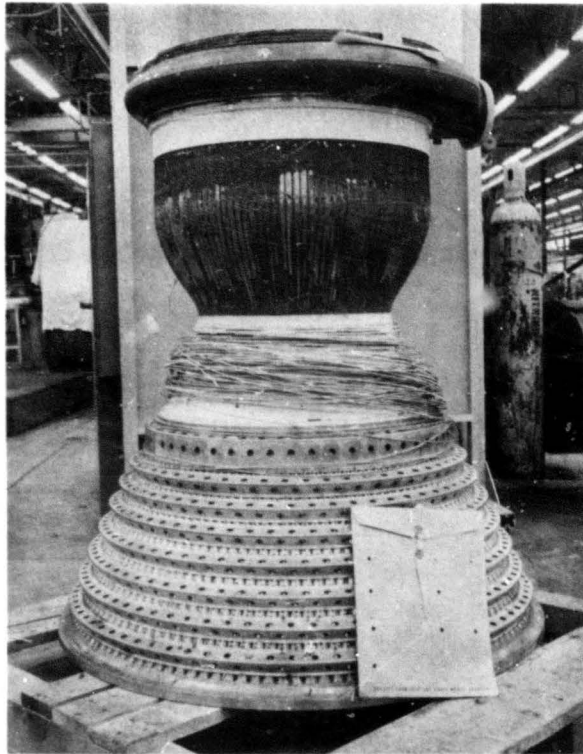
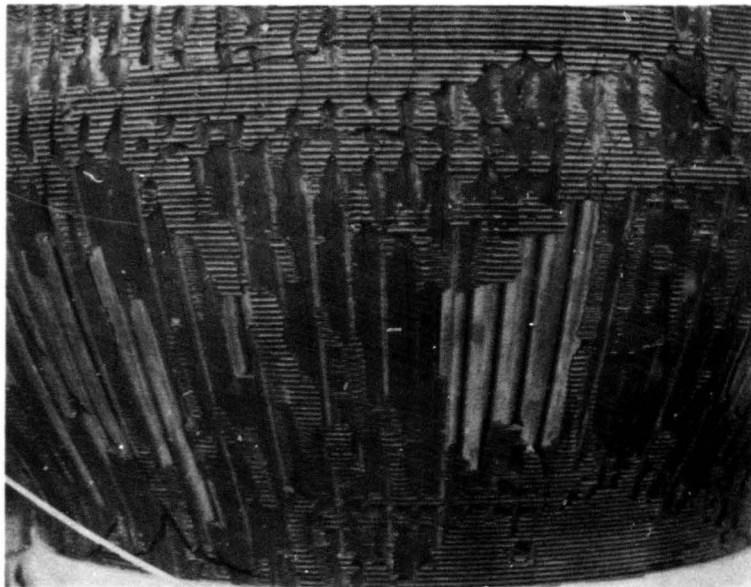
Figure 5 -- Combustion Chamber S/N 001, Showing Failure of Wire Wrapping

Failure analysis of the wirewrap separation produced the following information:

(a) Posttest inspection revealed an unwrapped condition from approximately 3 in. below the torus to approximately 1 in. above the throat. These tubes were bulged approximately 1/2 in. in the convergent section, and the tubes appeared to be elliptical in this area.

(b) Material evaluation indicated there was an insufficient thickness of Epon over large portions of the wirewrapped area. It was apparent by visual inspection that the Epon was not flush with the high point of the wire. Samples of Epon were visually examined and found to be acceptable in respect to material properties.

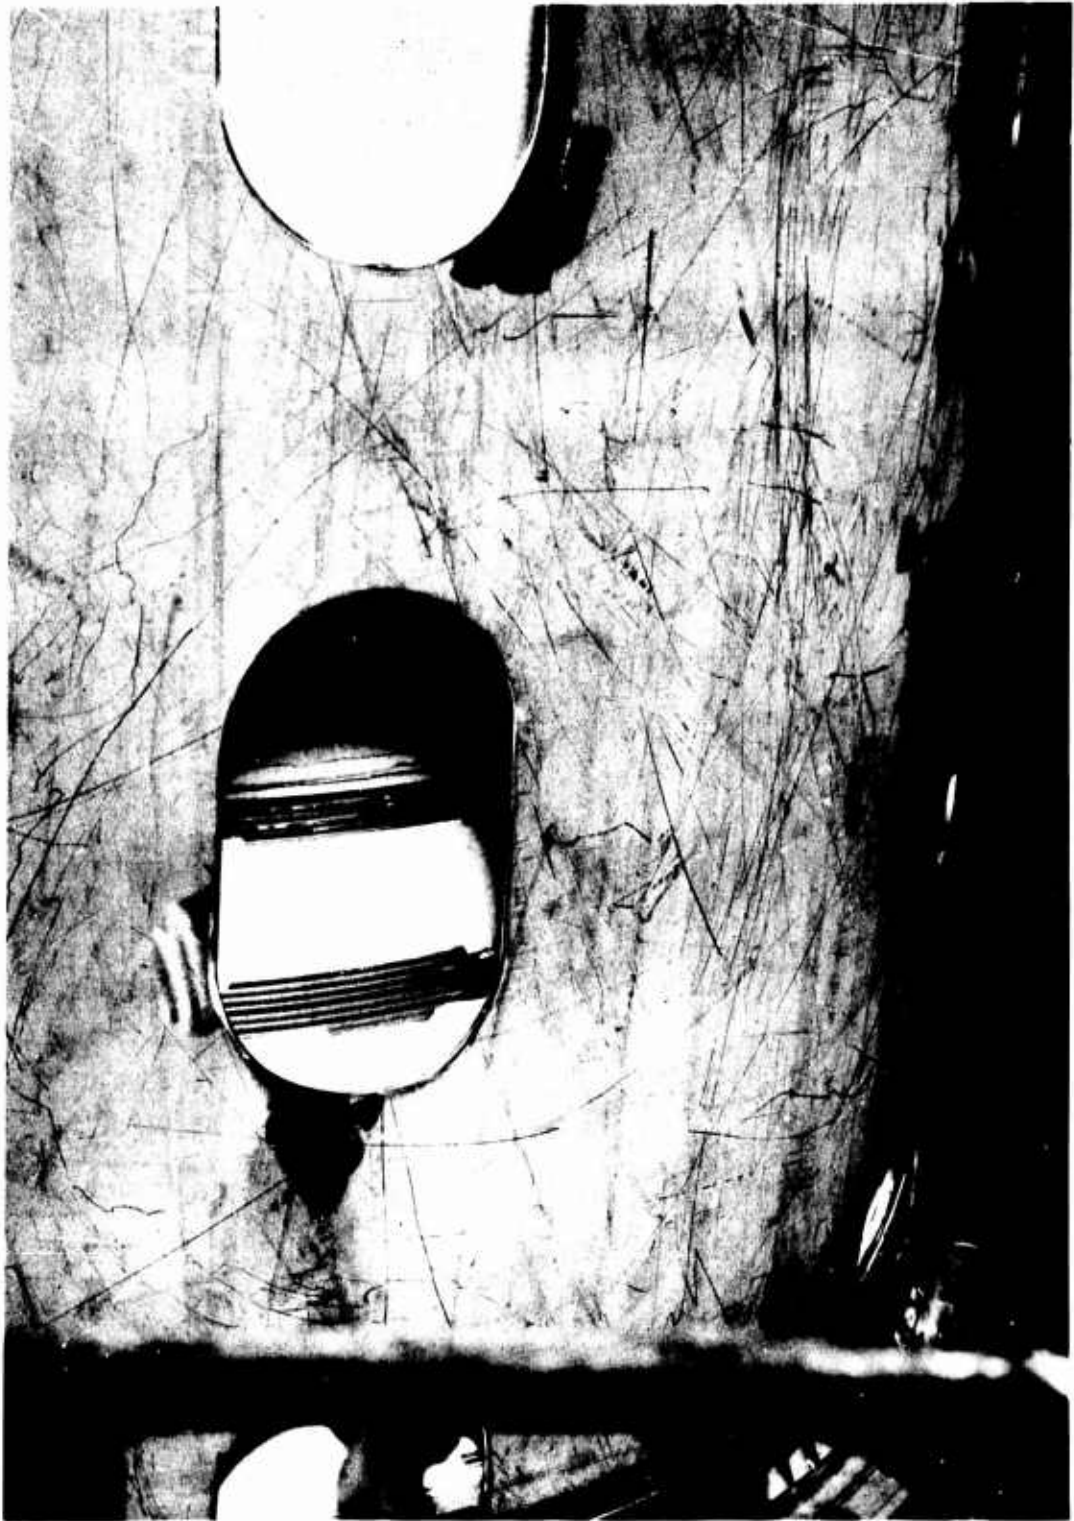
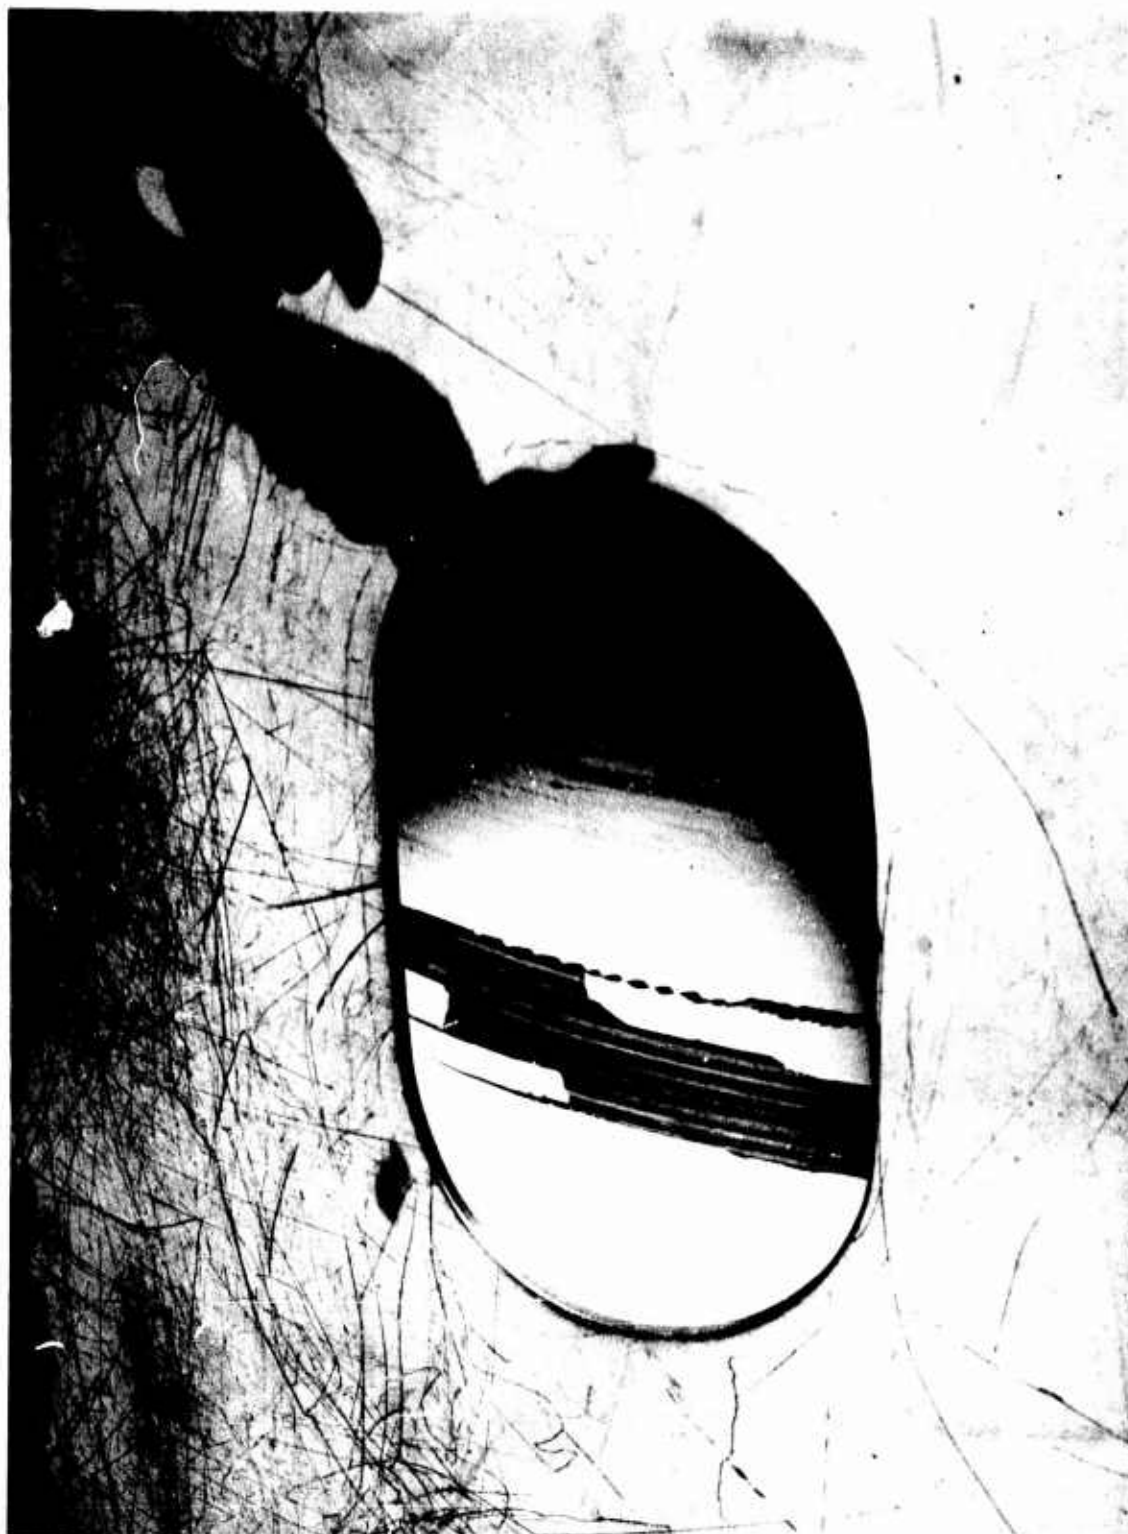
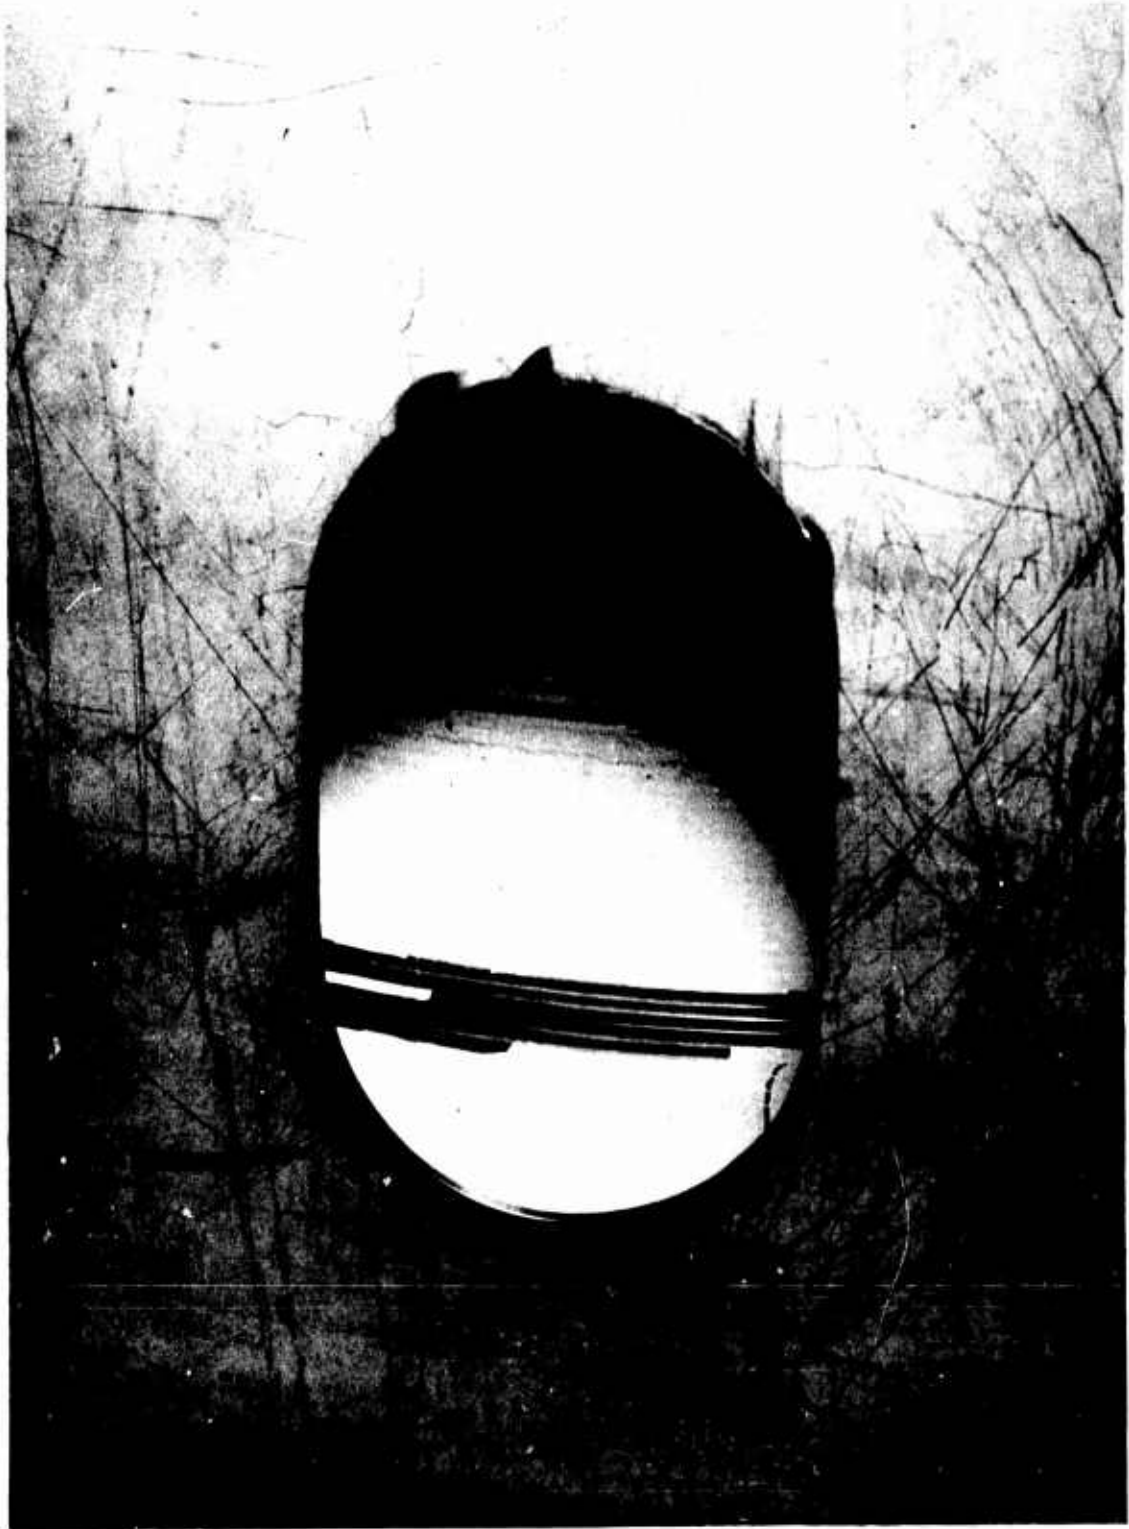
After the first test of Demonstration Engine S/N 14 (Demo 14) the wirewrap on the divergent section of chamber S/N 020 was loose (see Figure 6). The loose strands started about 1 inch aft of the throat plane and extended over 2 inches of the nozzle length. Two additional tests were conducted with the loose wire. For the second of these tests the wire was taped in place to hold the wire in position during the start transient. The wire was removed after this test, but it was never replaced because the chamber was withdrawn from the test program.

During initial fabrication, the chamber had been wirewrapped twice in the forward section (forward of the throat plane), the second time because the wire was loose after completion of final proof-and-leak testing. The wire in the aft section did not appear loose and was not similarly replaced. No specific cause for the loose wire in the forward section was ascertained, but it was noted that the surface of the wire was not clean. Little effort was necessary to strip the wire from the chamber, and no adhesive forces were apparent between the wire and the Epon bed. When the aft wirewrap was removed after loosening, the wire was also found to be dirty.

The looseness of the wire is not fully explainable, but it can be attributed to the same elements that caused the forward section of wirewrap to loosen during proof testing. The cleanliness of the wire and the depth of Epon during wrapping are believed to be important in maintaining wire location and tension through adhesion of the Epon bed to the wire. The corrective action calls for stripping both wire sections if either loosens during fabrication and for cleaning the wire to a degreased condition prior to and during wirewrap.

Figure 6 --- Loose Wire Wrap --- Chamber S/N 020 after Test No. 3051-D07-1A-201 (1 of 3)

The corrective action was limited to adding cleaning operations to the wirewrap procedure and requiring that both wirewrap sections be stripped

and replaced if either must be replaced. The cleaning consists of vapor-degreasing of the spool of wire in a hot atmosphere and, as the wire is wrapped, cleaning it with a cold degreasing agent applied to felt wipers on the wirewrapping machine. The wrapping procedure specifies the requirements for maintaining the felt pads at adequate effectiveness.

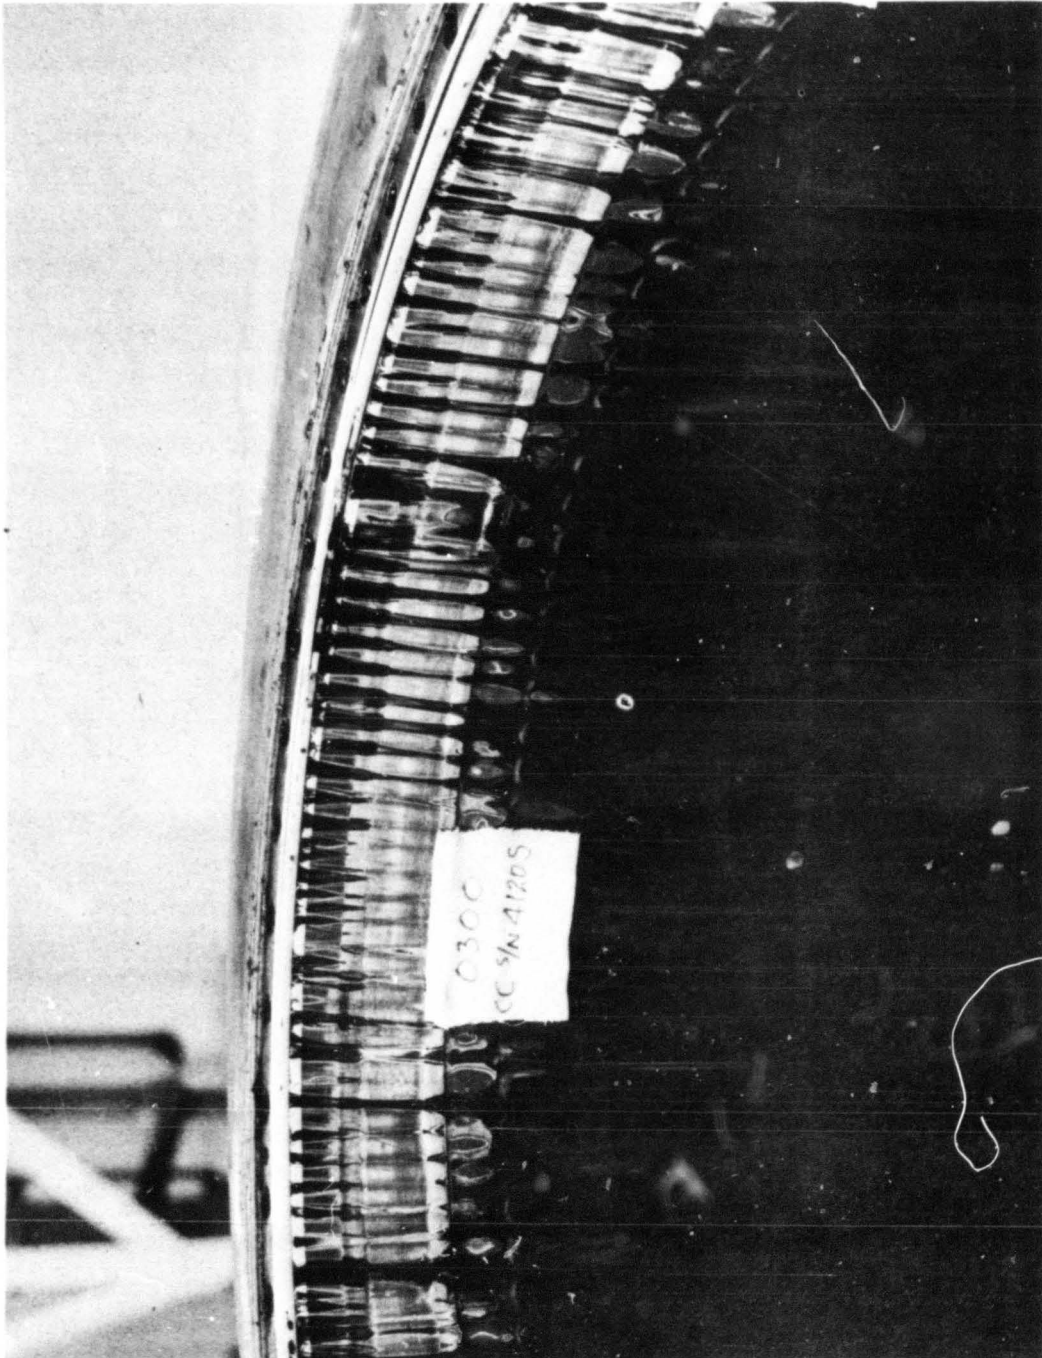
Figure 8 -- Forward Flange -- Chamber S/N 003 after Test No. 3051-D01-1A-008

During the development and early verification testing there were instances of heat marking and erosion on the forward flange such as shown in Figure 8. This was attributable to inadequate dispersion of the fuel film cooling from the baffle injector. The film cooling pattern of the injector was modified as shown in Figure 9. Thereafter such minor instances of erosion as occurred were all within acceptable limits as given by the specification.

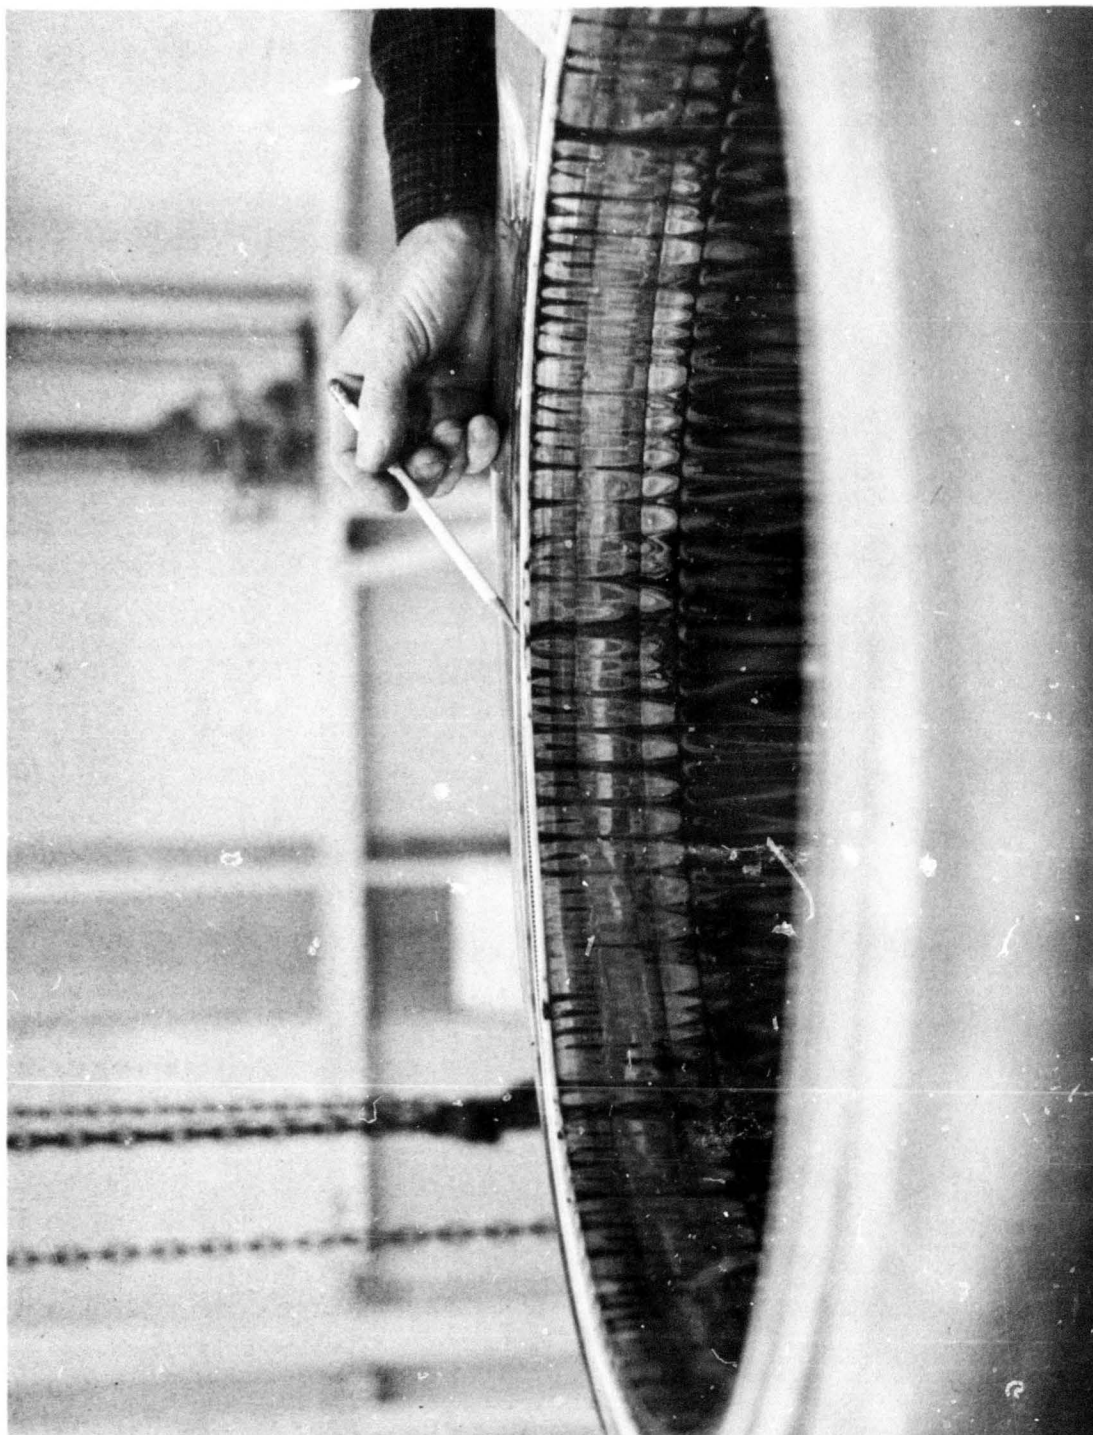
Figure 13 -- Raco Seal Leak

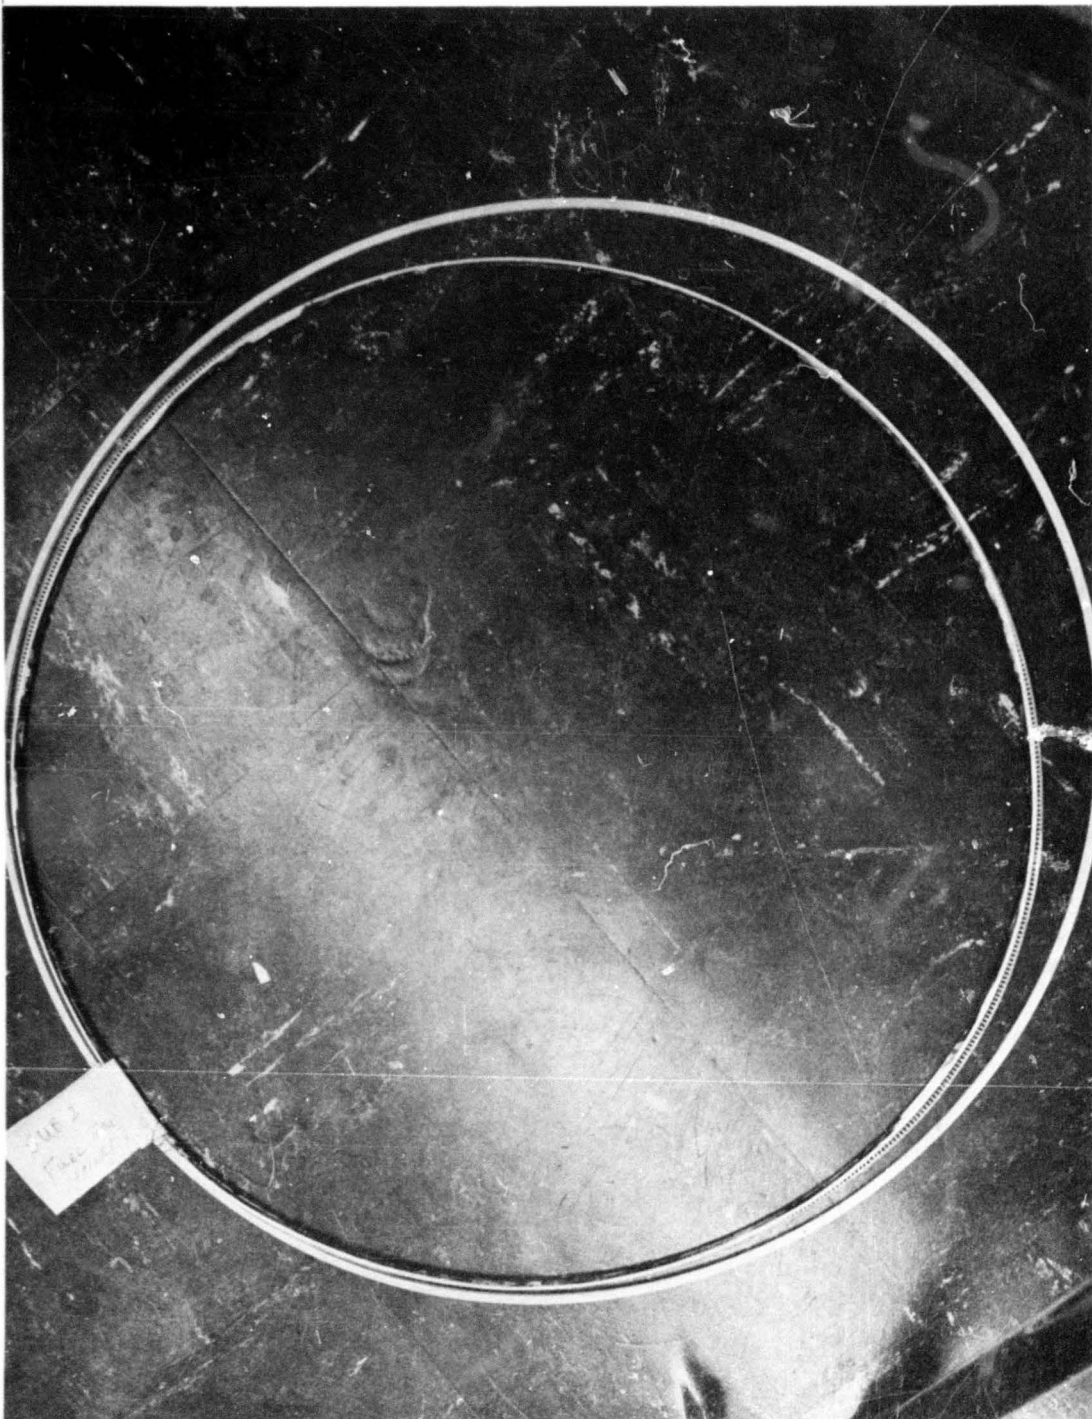
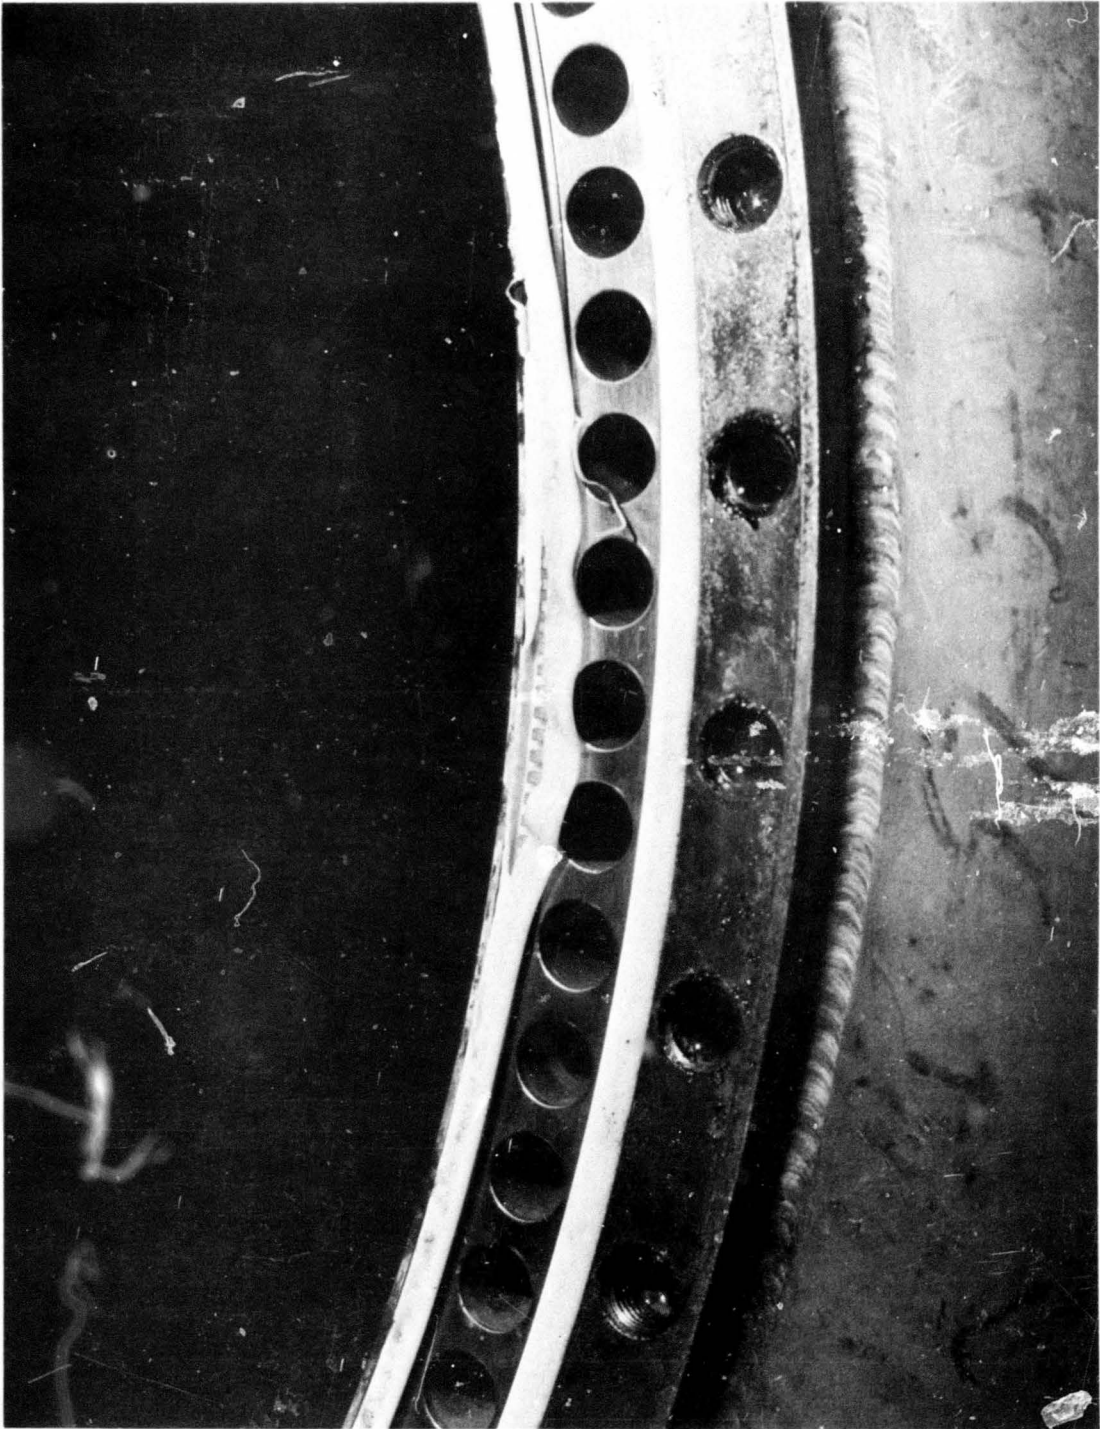
Figure 14 -- Damaged Raco Seal (1 of 2)

Figure 14 -- Damaged Raco Seal (2 of 2)

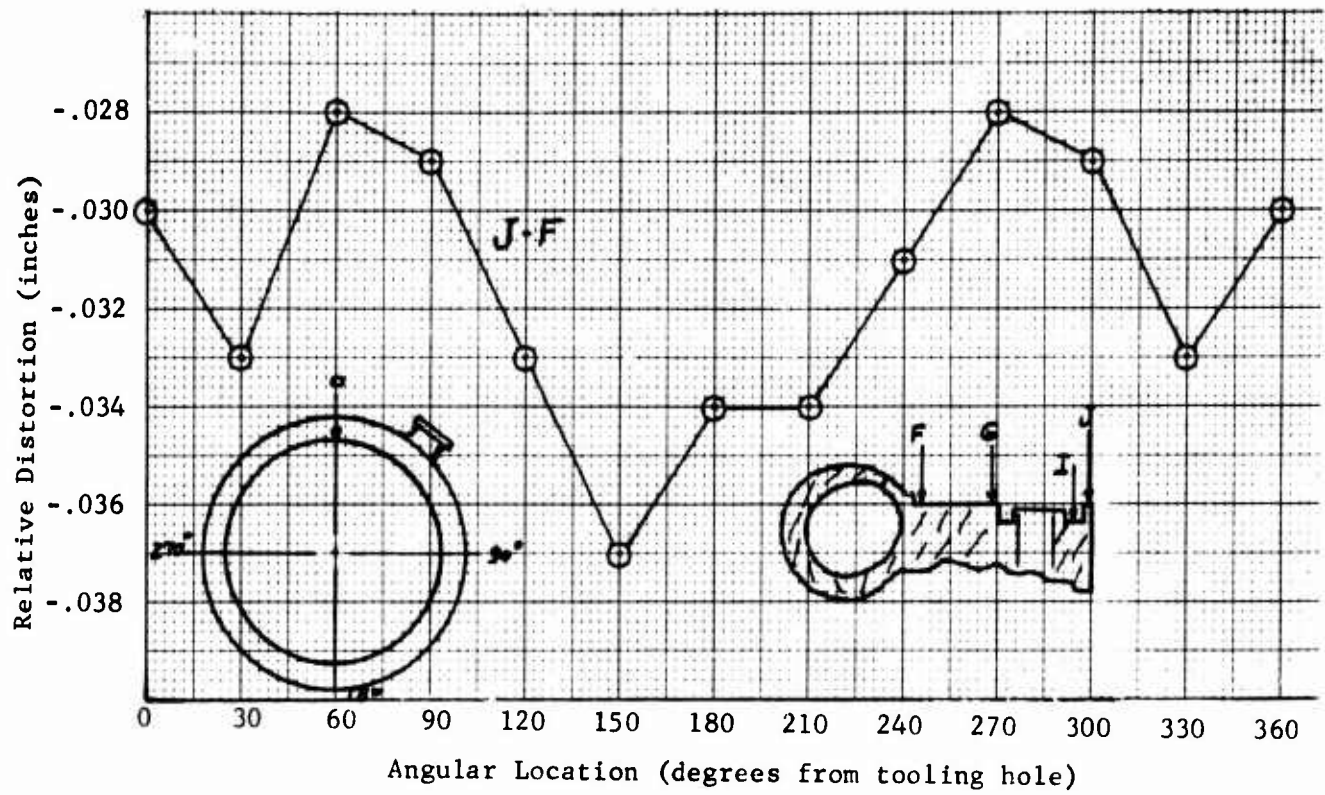
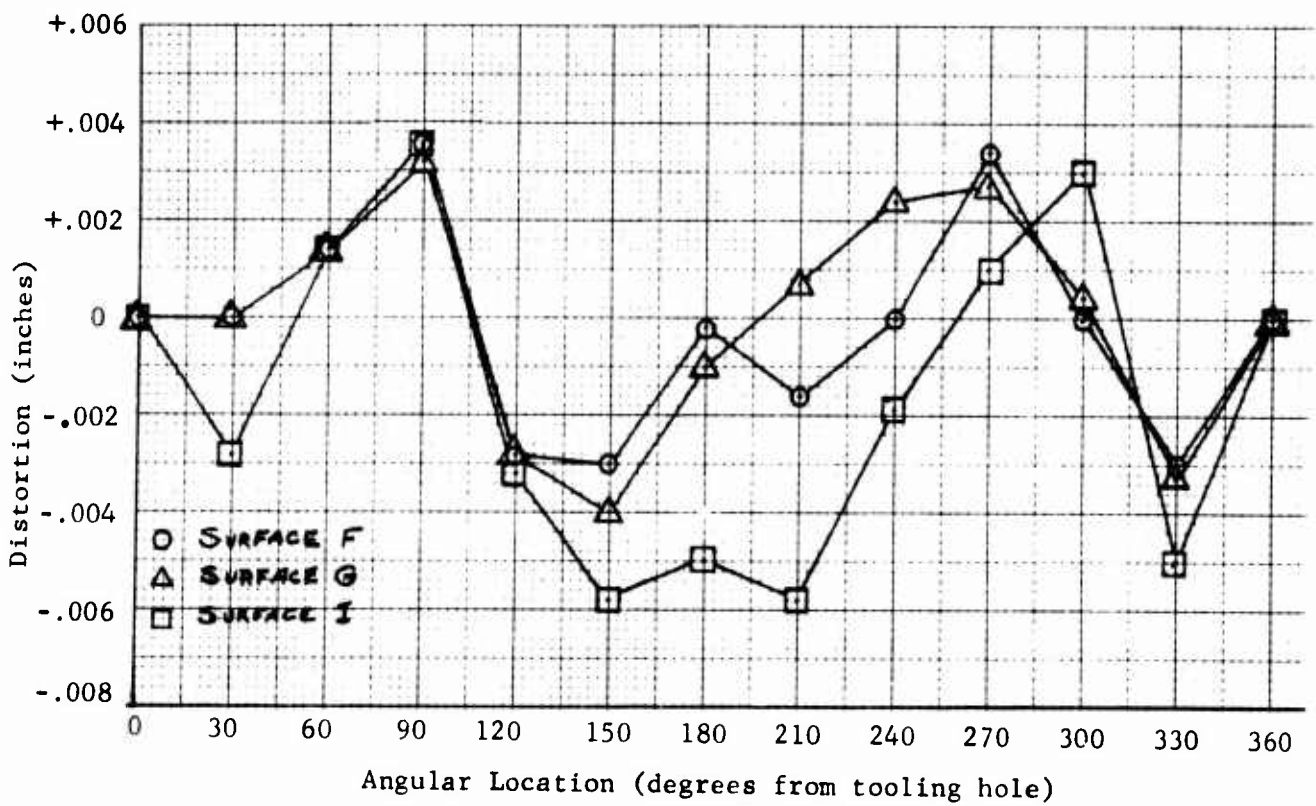
Distortion of the forward flange similar to that shown in Figure 20 occurred on both chambers S/N 019 and S/N 020 after the cover band weld repair. The injector feed holes which are drilled on a 22.730-in. diameter were on a diameter of 22.516-in. after the weld repair. This contraction caused an interference between the feed holes and the outer diameter of the inner seal groove. The alternatives then were: (1) to machine the seal grooves per blueprint and let the groove outer diameter break into the feed holes as occurred on S/N 017, or (2) to machine the inner seal inside diameter to blueprint and adjust the outside diameter to provide the minimum width groove required for correct Raco seal installation and operation.

Figure 20 -- Forward Flange Map--
Combustion Chamber S/N 018

Alternative (2) was therefore selected as the more satisfactory means for correcting the problem in chambers S/N 019 and S/N 020. Drawing No. 701773 (AEIP seal utilized for Titan IIIM at the inner seal) requires a minimum seal groove width of 0.195 while the chamber flange per B/P 1130174 is designed for a minimum groove width of 0.214 in. The chambers were machined as shown on Figure 21. All dimensions are to be to blueprint with the exception of the 22.167 in. dia, which normally is 22.250 ± 0.010 in. dia.

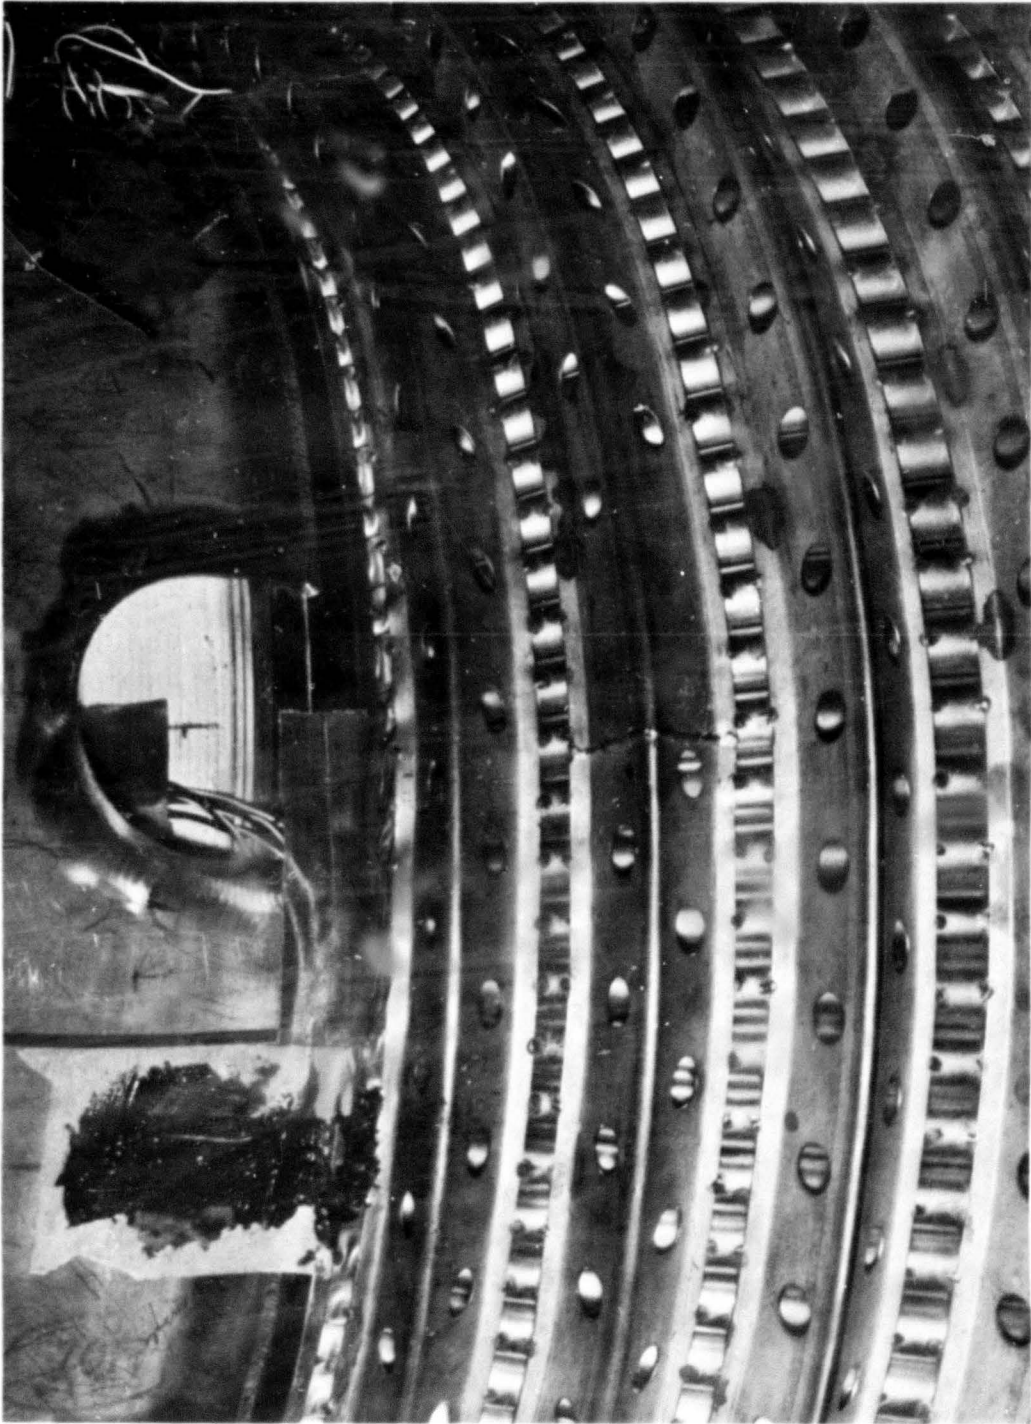
Figure 35 -- Chamber S/N 010 -- Closeup of Failure

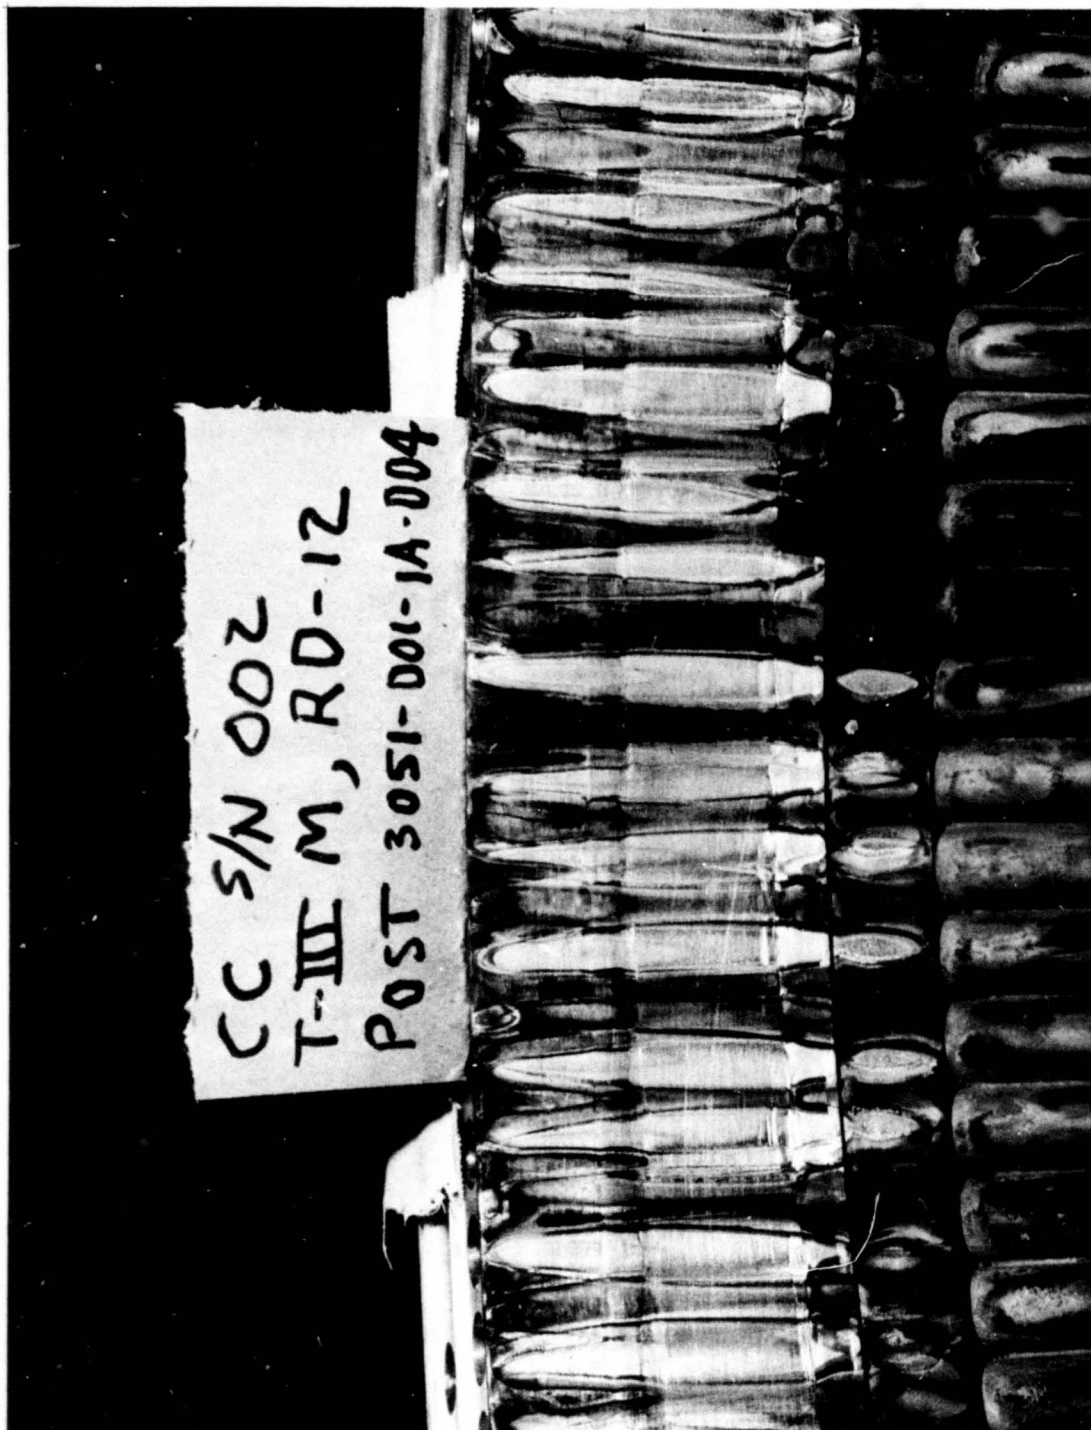
Test -005 was conducted utilizing injector S/N 249 (AJ-9 with 16 percent film cooling) and an ablative skirt at the most adverse heat transfer conditions for the skirt. Posttest inspection of chamber S/N 002 after engine Test No. 3051-D01-1A-005 revealed that one chamber tube was heat marked in the divergent section from approximately 18 inches below the throat to the aft end of the tube. Figures 48 and 49 show the location relative to the chamber. Penetrating erosion had occurred in two places (Figure 7, supra). All other chamber tubes were in satisfactory condition.

Figure 47 -- Chamber S/N 002, Showing Minor Erosion to Flange

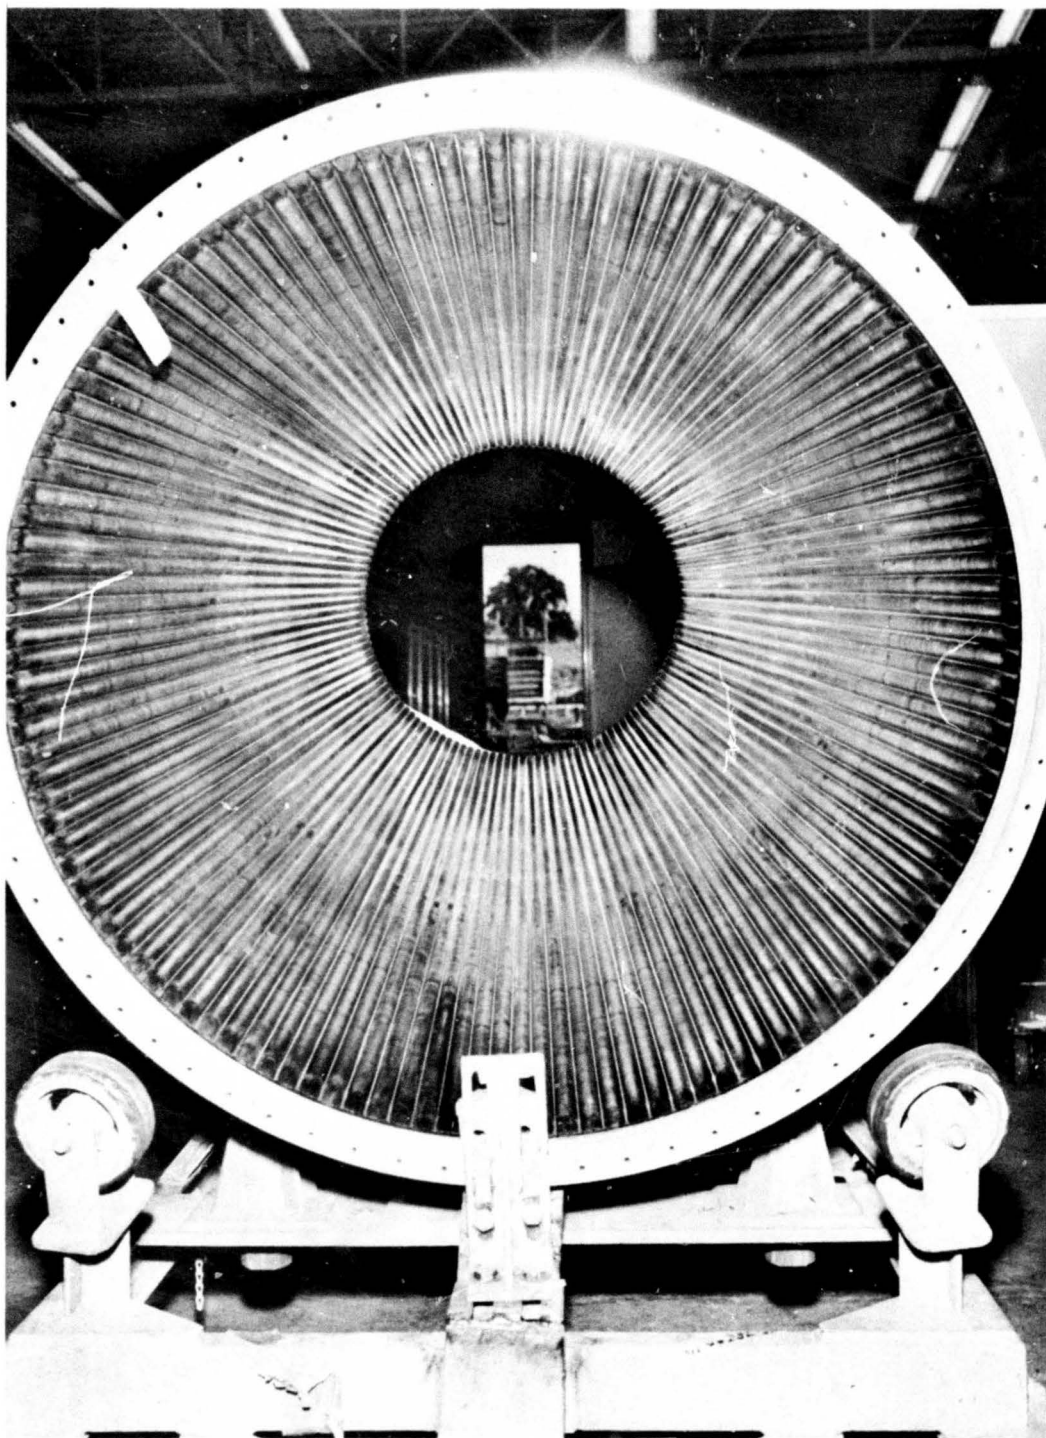
Figure 48 -- Combustion Chamber after Test No. 3051-D01-1A-005

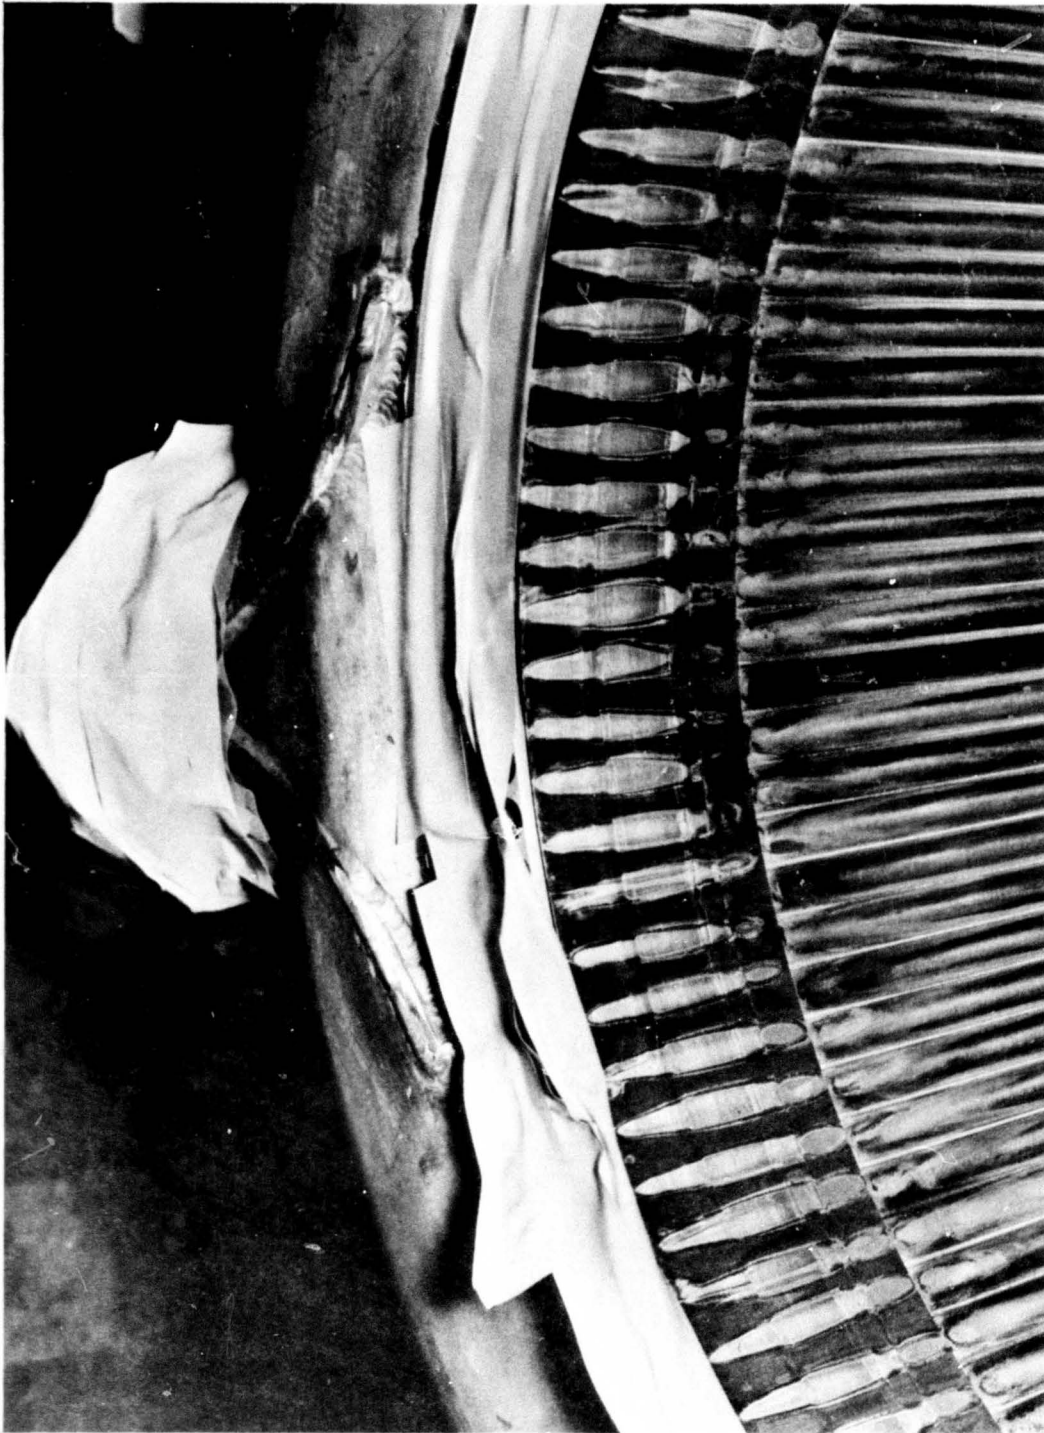
Figure 49 -- Chamber Flange Showing Heat-Marked Tube
